Manhole Inspection Summary

Manhole # S41II_030MH

Insp Date: **9/1/09 9:53 AM**

Location Address: **HARFORD AVE**

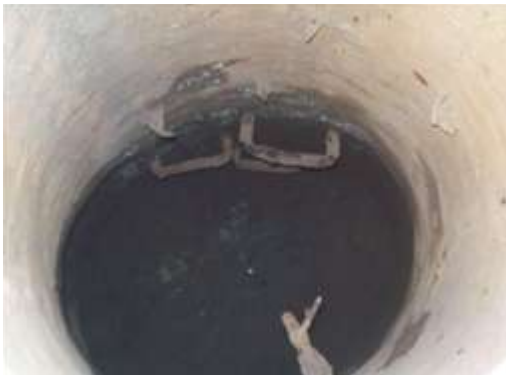
Defect 1

Count: **5** Missing: **2** ☒ **Corroded**

CORROED STEPS

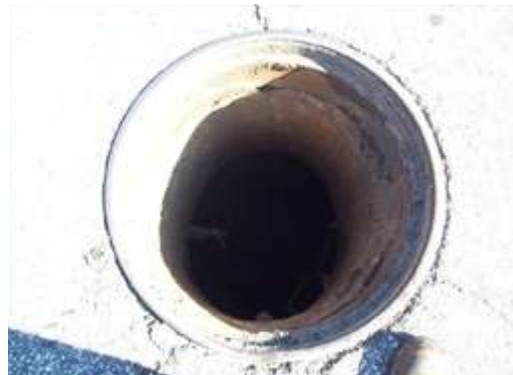
Defect 2

Offset: **2** (in.)

Condition: ☐ Sound ☐ Cracked ☐ Root Intrusion ☐ Loose Brick ☒ **Deteriorated**

deteriorated chimney and frame offset

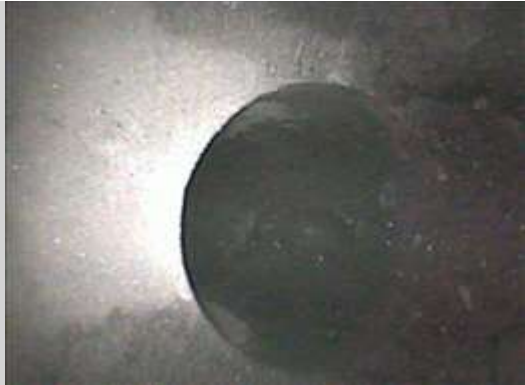
12 O'Clock Outflow

8 in. Circular Gravity Sewer
Pipe Out @ 12 O'Clock

Deposits: ☐ None ☐ Mud ☐ Sludge ☒ **Debris** ☐ Grease

Silt Depth: **3** (in.) Deposits Extent: **Medium**
